**Pond ecology survey
and
management suggestions
Cranberry Moss,
Alsager,
Cheshire**

Dave Bentley Ecology Services
www.davebentleyecology.co.uk
Version 1.1 May 2016

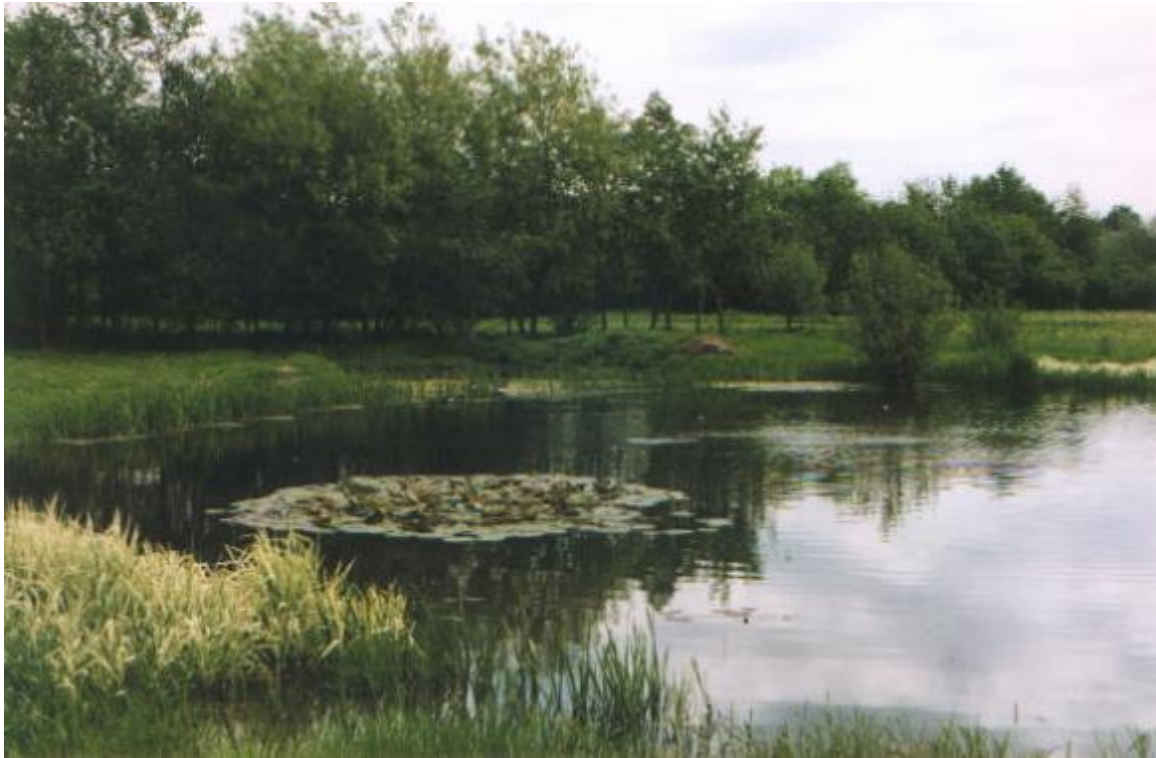
- 3.13 Photographs of the pond from 1997 and 1998 found online show an open water body with fringing vegetation and a patch of water-lilies. There is immature surrounding tree planting.
- 3.14 Satellite images from 2003 show the garage complex is now housing, and the western large house plot is now developed for housing.

Pond 26 May 1997 (from www.alsager.com)(above) Platform and bay to rear (from south)

- 5.9 Existing platform and dipping area renovation. The existing platform seems to be sound and might be cleaned up. The photographs from 1997/8 show that it was purpose built as a dipping platform alongside a specially created shallow bay. Lesser Pond Sedge has closed up the area. The bay could be cleared of vegetation to recreate the shallow open water area.

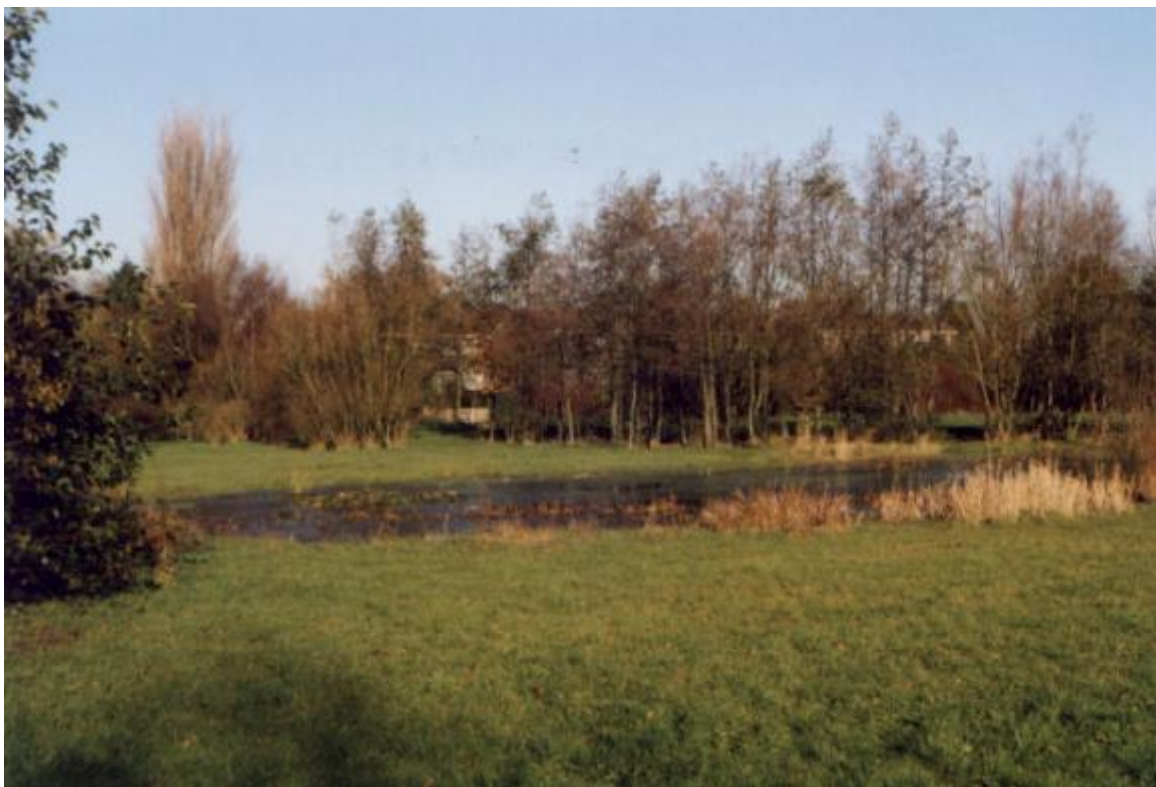
Pond Nov 1998 (from www.alsager.com)(above)(from south west)

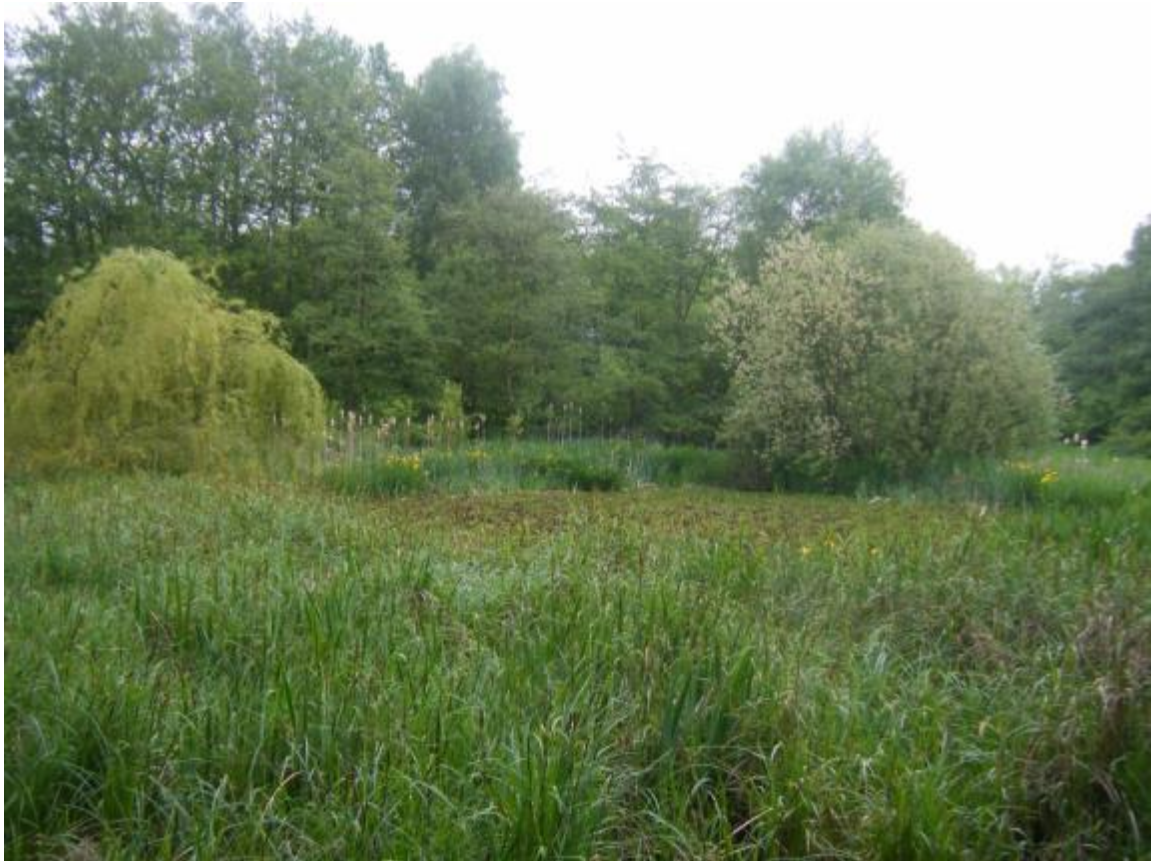
- 4.8 Water Soldier is the spikey, floating plant currently occupying all of the open water of the pond. The plant is regarded as Near Threatened internationally and Nationally Rare in its supposed native habitats in the east of England from East Yorkshire to the Norfolk Broads. There is evidence of complete loss in much of its natural range. However it is often introduced to garden ponds and then cast into the wild. One source (Aquatic Plants in Britain & Ireland by Preston & Croft) suggests it may be native in Cheshire. We only have female plants in the UK meaning the plant does not seed, and some suggest that it may not be native to the UK because of this, although it was known to 17th Century English botanists. The probable young age of the pond (first appearing on air photographs in 1971-3) and the fact that the plant does not appear on the photographs from 1997 and 1998 shows this must be an introduction, and hence of little conservation interest. Note the plant is said to favour open ponds or ditches where reeds are suppressed by clearance. There is an example of where a Council owned pond in Penwortham, near Preston, was part cleared of this plant, and it was taken to a Council lake which lacked vegetation. The plant is now a serious problem in that lake, as told by satellite imagery. Here the plant was not found to support many aquatic invertebrate species, as its rigidity does not provide a diversity of habitat structures.

Pond from west (from platform) 23 May 2016 (above)

- 5.2 Water Soldier. If the idea is to create an area of open water this will require regular management year on year as Water-soldier is quick to recolonise. It would be a simple matter, say to hire Conservation Volunteers. One could pull, out using rakes, Water Soldier and place it on a tarpaulin and then drag it to an area of brambles where it can be dumped. It would be necessary to check for nesting birds in the clearance and deposition areas before starting work. Plants other than Water-soldier and Nuttall's Waterweed should be returned to the water (with any loosened animals) where hopefully they will have the room to spread.

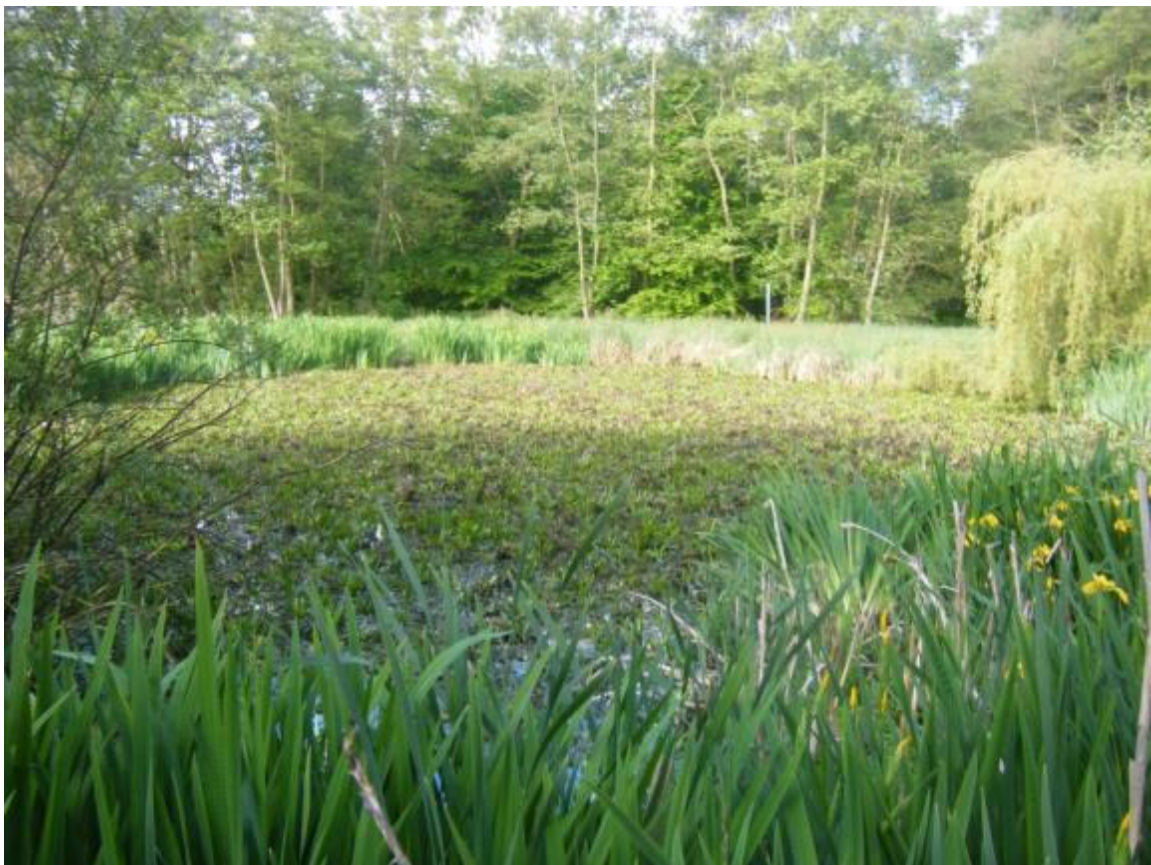
Pond from east (from island) 23 May 2016 (above)

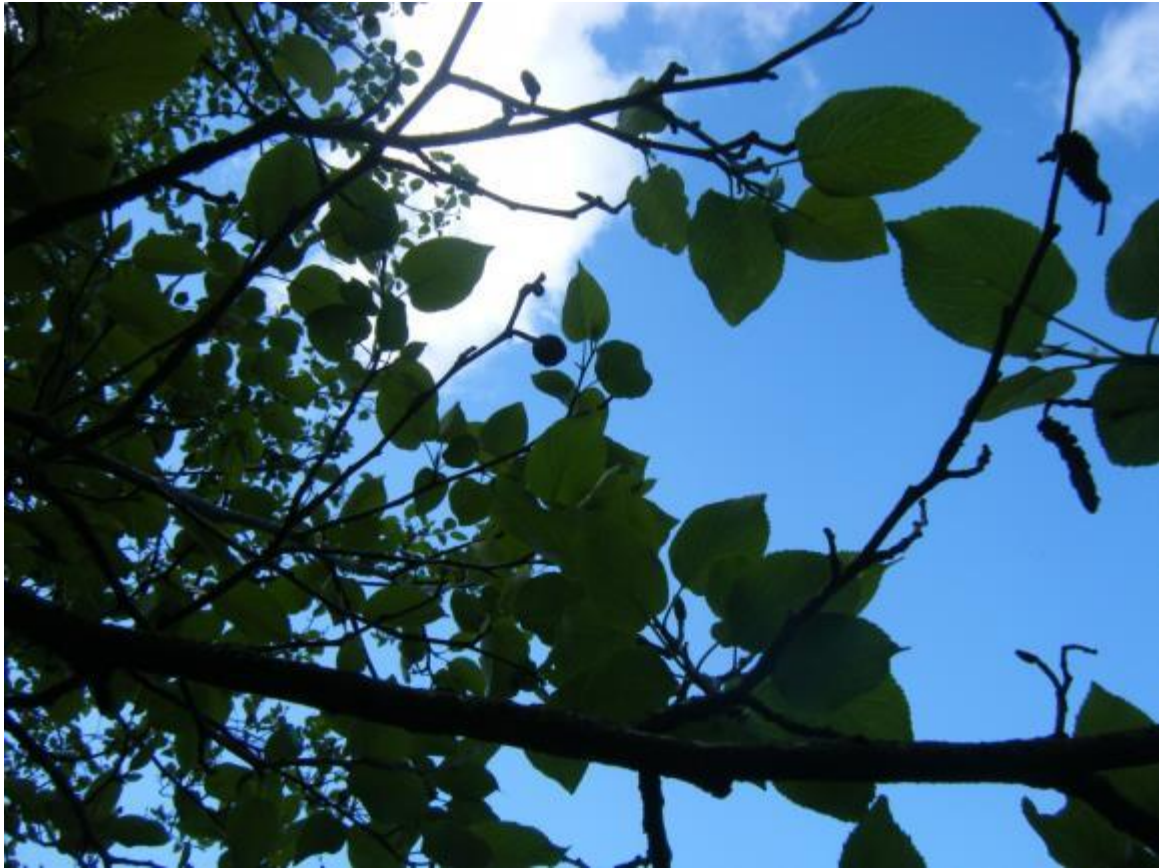
- 4.15 The wetland trees need to be controlled/removed urgently from the pond area. There are English Alder, Italian Alder and Grey Alder (from North America), plus Grey Willow, Goat Willow, Crack Willow, and an alien Weeping Corkscrew Willow. Wetland trees lower water tables, drop leaves and branches into the water, shade water and ground flora and

Leaves and cones of Italian Alder (above)

- 5.5 Trees. Whilst trees and ponds do not mix well, several tree species are particularly problematic. If young trees are allowed to grow into large trees a small problem becomes a problem that is very hard and expensive to overcome. Of particular concern are the Weeping Willow, Crack Willow, Grey Willow and English Alder that grow within the wetland. These should be removed as a priority. The *Prunus* on the north east bank will also prove to be a problem (Wild Plum or Blackthorn) as *Prunus* spreads by suckering and soon becomes a thicket which eliminates ground cover. The inclusion of Italian and Grey Alders in the planting scheme was an error. These non-native species require constant suppression, and where this does not happen, they soon change the character of wet woodland. The alien trees should be removed from the whole Nature Reserve. It would be best to spray-paint them or tape them to identify them in full leaf and then have them removed outside the bird breeding season. Once the alien trees are removed consideration can be given to thinning or removing other trees growing nearer the pond. Priorities – trees within the pond and on the banks; next alien trees throughout the reserve; finally reduce/remove the two blocks of woodland adjacent the pond.

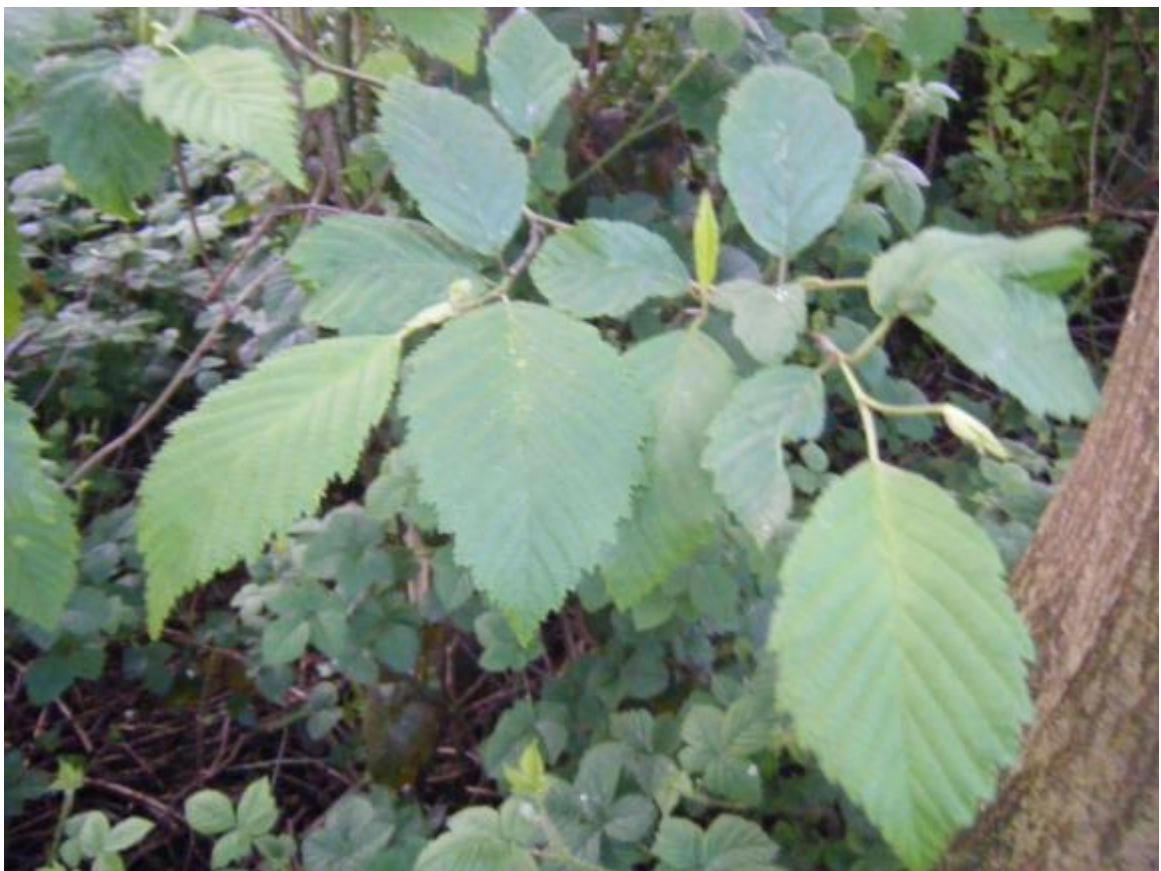
Leaves of Grey Alder (above)
